MSFC Safety *Bulletin*

Curing Oven Fire Lessons Learned

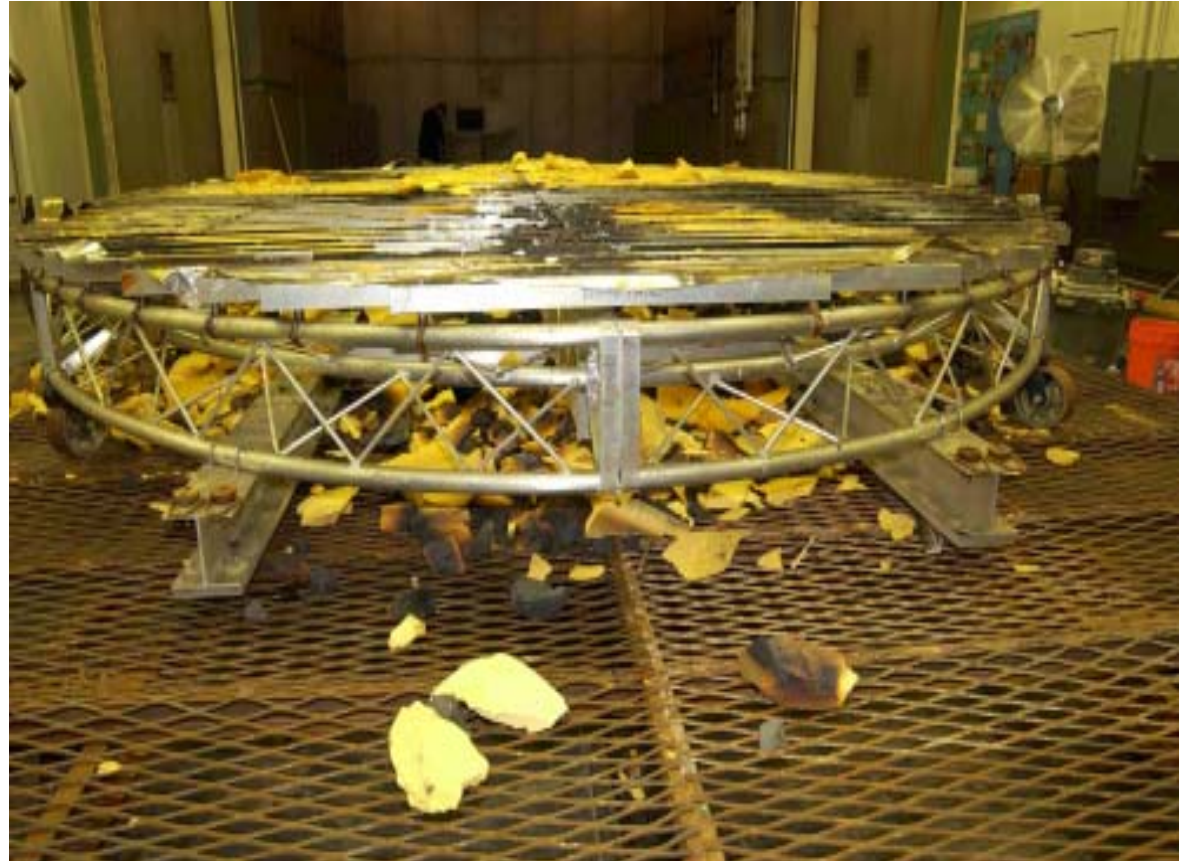
While curing a tooling mandrel, a fire occurred in the Building 4707 Despatch Oven. After the mandrel was broken up by the Redstone Arsenal Fire Department and removed to a foam dumpster located in the rear of Building 4707, the fire, which was believed to be out, reignited in the dumpster.

- Exothermic reaction(s) of an epoxy tooling paste and/or a highly insulating phenolic foam material sold under the trade name Thermo-Cor™.
- Thermo-Cor™, which caught fire, bore similarities to Spray on Foam Insulation (SOFI) that had previously caught fire during spray application.

- Operations involving a potential exothermic reaction surrounded by highly insulating material are a high fire risk.
- Equipment which can be used for a variety of operations involving many types of materials poses unique challenges. A safety assessment should be performed prior to the start of each unique operation.
